**Flood Control Project Maintenance
Levee Inspections**

Fall 2016 Levee Maintenance Deficiency Summary Report

Reclamation District No. 2103 Wheatland Vicinity

Fall 2016 Levee Inspection Results

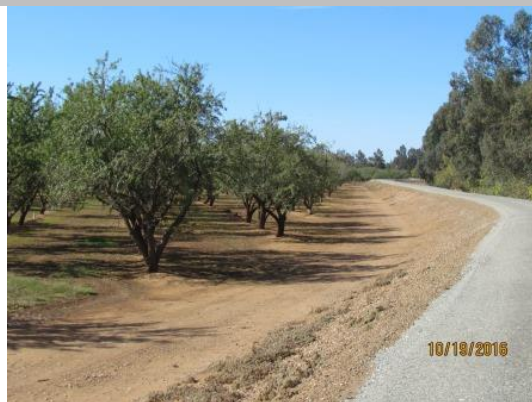
Photo 1 of 1 : FA_2016_RD2103_10_19_20161025_00037.jpg

View of well maintained vegetation on the landside looking upstream.
Fall 2016.

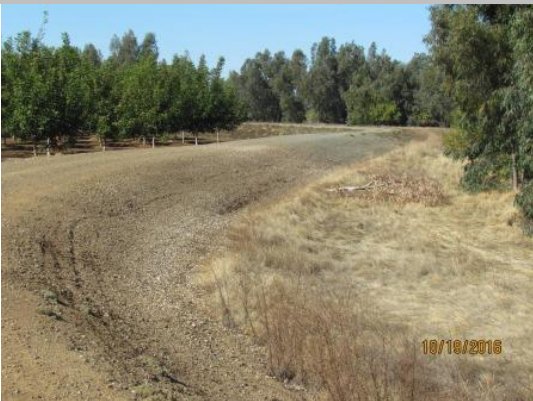
Photo 1 of 1 : FA_2016_RD2103_10_21_20161025_00038.jpg

View of well maintained vegetation on the waterside looking upstream.
Fall 2016.

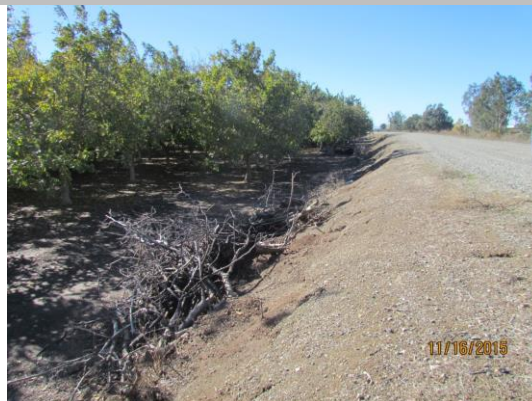
Photo 1 of 2 : FA_2016_RD2103_10_22_20160906_00005.jpg

View of the pruning pile at the toe of the levee on the landward side. Fall 2015.

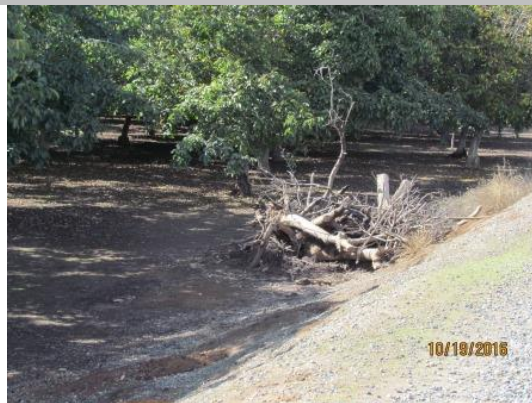
Photo 2 of 2 : FA_2016_RD2103_10_22_20161025_00041.jpg

LM Start	0.22	Rating **	M	Issue No.	22 (cont)
LM End	0.22	Issue Type +	En	Location *	LS

Pruning's still exist as of Fall 2016.

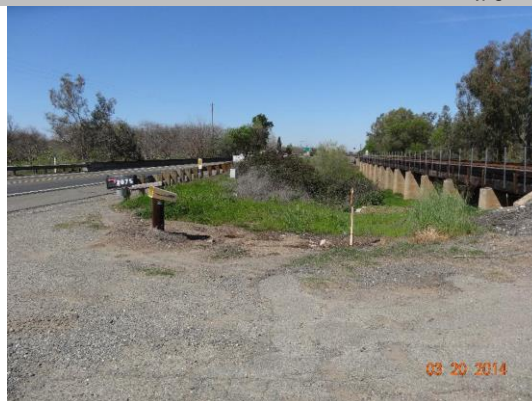
Photo 1 of 2 : UCIP_FA_2016_39985_69852.jpg

FS_ID:39985
DS_ID:19468
EP_NO: 3659
Repair Type: Non-Urgent
Crossing Status: Indicator Found
UCIP Comments: Need to contact owner to determine status of crossing. Need date of last inspection and confirmation that crossing is still in operable condition. It appears this is the same line as the next entry however, permit calls for Southern Pacific Pipe Lines, Inc as the owner and the sign found in the field indicates Kinder Morgan as owner. Need to contact owner to clarify if 2 crossings exist or if crossing is same owner will need to update permit information.
FIELD_STRUCT_DESC: 8-5/8-inch steel fuel line through the levee, 3.0 feet below the crown. Cutoff wall around pipe at centerline of levee. Pipe extends through overflow area. (Permit No. 3569-1961). This entry matches the Drainage or Irrigation Structure referenced in O&M manual (HLM 0.55). Markers visible on both sides.
FS Date: 3/20/2014

Marker visible on toe in between railroad tracks and highway (north).

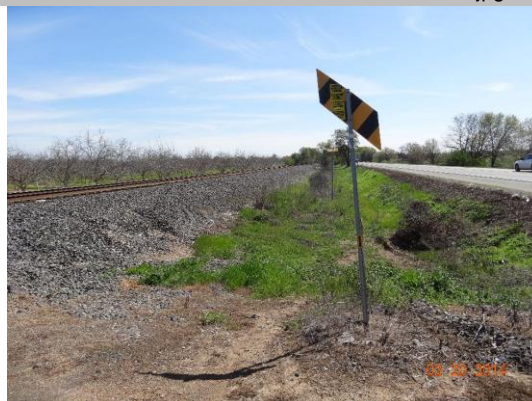
Photo 2 of 2 : UCIP_FA_2016_39985_69851.jpg

Marker visible on toe in between railroad tracks and highway (south).

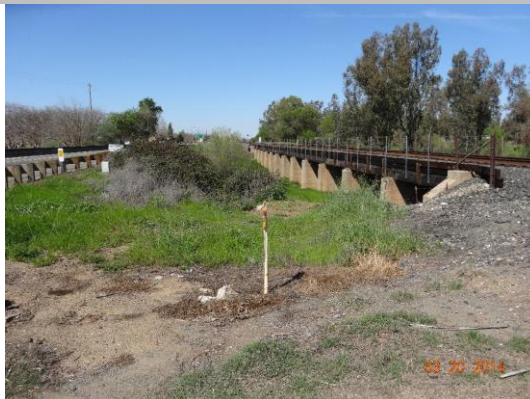
Photo 1 of 2 : UCIP_FA_2016_39986_71882.jpg

Comment Code					
Inspector Comment					
FS_ID:39986 DS_ID:24878 EP_NO: N/A Repair Type: Non-Urgent Crossing Status: Indicator Found UCIP Comments: It appears this is the same line as the next entry however, permit calls for Southern Pacific Pipe Lines, Inc as the owner and the sign found in the field indicates Kinder Morgan as owner. Need to contact owner to clarify if 2 crossings exist or if crossing is same owner will need to update permit information. Also need to contact owner to determine status of crossing. Need date of last inspection and confirmation that crossing is still in operable condition. FIELD_STRUCT_DESC: Kinder Morgan line through levee. Markers visible on both banks. FS Date: 3/4/2014

View of marker visible on waterward side (between HWY 65 and railroad).

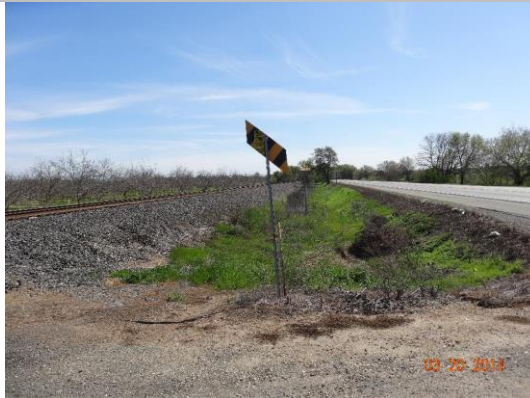
Photo 2 of 2 : UCIP_FA_2016_39986_71881.jpg

Markers visible on landward side.

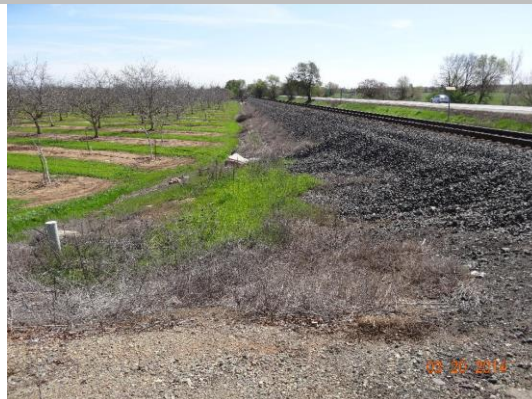
Photo 1 of 1 : UCIP_FA_2016_43823_73340.jpg

LM Start	0.55	Rating **	M	Issue No.	37
LM End	0.55	Issue Type +	En	Location *	LS
Category	Supplemental			GPS Latitude/Longitude	
				Start	End
Item	DWR UCIP Field Study			39.022654 °	39.022654 °
				-121.444665 °	-121.444665 °
DWR ID					
Comment Code					
Inspector Comment					
FS_ID:43823 DS_ID:19467 EP_NO: 16041 Repair Type: Non-Urgent Crossing Status: Indicator Found UCIP Comments: Needs markers at levee crossing. FIELD_STRUCT_DESC: 2-inch steel communication conduit encasing telephone cable through the levee, 2-feet below the crown. Extends to junction box 10-feet from landward toe, parallel to railroad tracks. (Permit No. 16041-1993). FS Date: 3/18/2015

Junction box visible on LS toe (at lower left of photo).

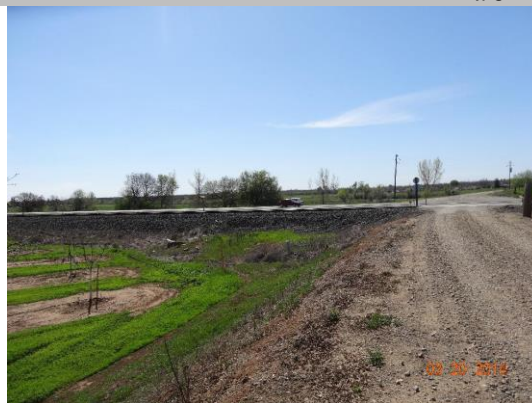
Photo 1 of 2 : UCIP_FA_2016_39987_71885.jpg

LM Start	0.56	Rating **	M	Issue No.	35
LM End	0.56	Issue Type +	En	Location *	LS
Category	Supplemental			GPS Latitude/Longitude	
				Start	End
Item	DWR UCIP Field Study			39.022665 °	39.022665 °
				-121.444688 °	-121.444688 °
DWR ID					
Comment Code					
Inspector Comment					
FS_ID:39987 DS_ID:24879 EP_NO: N/A Repair Type: Non-Urgent Crossing Status: Indicator Found UCIP Comments: Need to contact owner to obtain depth of line through levee. Also need permit authorizing conduit through levee. FIELD_STRUCT_DESC: Conduit line through levee. Markers visible on both sides. FS Date: 3/4/2014

View of landward side.

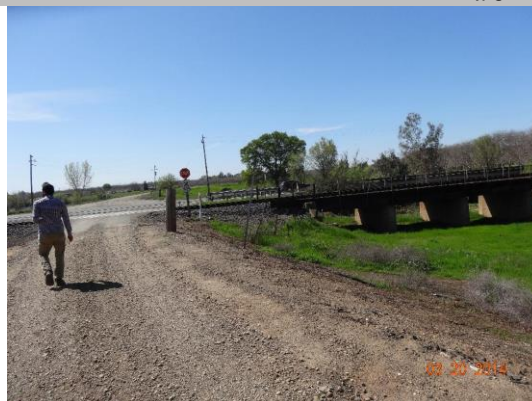
Photo 2 of 2 : UCIP_FA_2016_39987_71884.jpg

LM Start	0.56	Rating **	M	Issue No.	35 (cont)
LM End	0.56	Issue Type +	En	Location *	LS
Category	Supplemental			GPS Latitude/Longitude	
				Start	End
Item	DWR UCIP Field Study			39.022665 °	39.022665 °
				-121.444688 °	-121.444688 °
DWR ID					
Comment Code					
Inspector Comment					
FS_ID:39987 DS_ID:24879 EP_NO: N/A Repair Type: Non-Urgent Crossing Status: Indicator Found UCIP Comments: Need to contact owner to obtain depth of line through levee. Also need permit authorizing conduit through levee. FIELD_STRUCT_DESC: Conduit line through levee. Markers visible on both sides. FS Date: 3/4/2014

View of levee crown and waterward side.

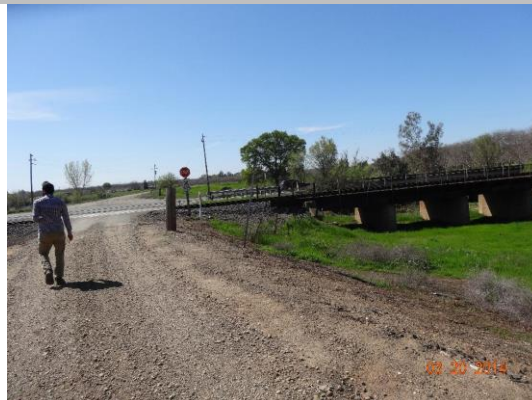
Photo 1 of 2 : UCIP_FA_2016_38323_69860.jpg

LM Start	0.56	Rating **	M	Issue No.	28
LM End	0.56	Issue Type +	En	Location *	LS
Category	Supplemental			GPS Latitude/Longitude	
				Start	End
Item	DWR UCIP Field Study			39.022733 °	39.022733 °
				-121.444626 °	-121.444626 °
DWR ID					
Comment Code					
Inspector Comment					
FS_ID:38323 DS_ID:19469 EP_NO: 2098 Repair Type: Non-Urgent Crossing Status: Indicator Found UCIP Comments: Need to contact owner to determine status of crossing. Need date of last inspection and confirmation that crossing is still in operable condition. FIELD_STRUCT_DESC: 16-inch steel gas line through the levee, 3.0 feet below the crown. Marker on waterward slope. (Permit No. 2098-1955). This entry matches the Drainage or Irrigation Structure referenced in O&M manual (HLM 0.56). FS Date: 3/20/2014

View of levee crown at crossing.

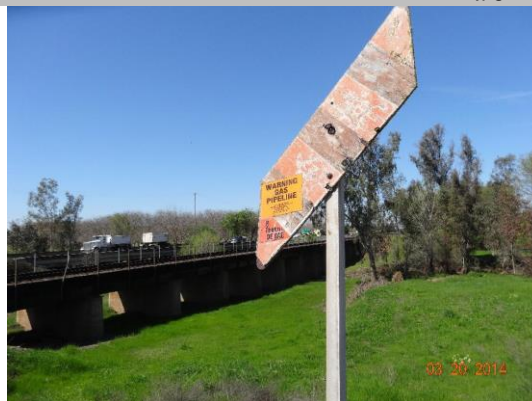
Photo 2 of 2 : UCIP_FA_2016_38323_69859.jpg

LM Start	0.56	Rating **	M	Issue No.	28 (cont)	
LM End	0.56	Issue Type +	En	Location *	LS	
Category	Supplemental			GPS Latitude/Longitude		
				Start		End
Item	DWR UCIP Field Study			39.022733 °		39.022733 °
				-121.444626 °		-121.444626 °
DWR ID						
Comment Code						
Inspector Comment						
FS_ID:38323 DS_ID:19469 EP_NO: 2098 Repair Type: Non-Urgent Crossing Status: Indicator Found UCIP Comments: Need to contact owner to determine status of crossing. Need date of last inspection and confirmation that crossing is still in operable condition. FIELD_STRUCT_DESC: 16-inch steel gas line through the levee, 3.0 feet below the crown. Marker on waterward slope. (Permit No. 2098-1955). This entry matches the Drainage or Irrigation Structure referenced in O&M manual (HLM 0.56). FS Date: 3/20/2014

Marker visible waterward side.

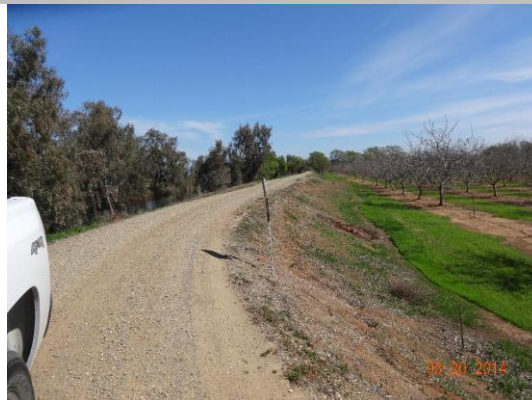
Photo 1 of 2 : UCIP_FA_2016_38324_69864.jpg

Comment Code					
Inspector Comment					
FS_ID:38324					
DS_ID:19470					
EP_NO: 789					
Repair Type: Non-Urgent					
Crossing Status: Indicator Found					
UCIP Comments: Need to contact owner to determine status of crossing. Need date of last inspection and confirmation that crossing is still in operable condition.					
FIELD_STRUCT_DESC: 16-inch steel gas line through levee, 3.0 feet below the crown. Concrete inspection chamber (24x18-inch with 4-inch walls) on the waterward shoulder, covered with dirt. Gas line marker on landward slope. Extends underneath Dry Creek channel, covered with concrete slab approx. 18-inches wide. (Permit No. 789-1939). This entry matches the Drainage or Irrigation Structure referenced in O&M manual (HLM 0.63).					
FS Date: 3/20/2014

View of levee crown looking upstream.

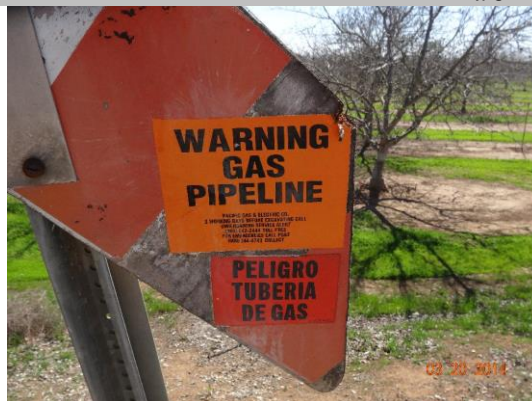
Photo 2 of 2 : UCIP_FA_2016_38324_69863.jpg

Comment Code						
Inspector Comment						
FS_ID:38324						
DS_ID:19470						
EP_NO: 789						
Repair Type: Non-Urgent						
Crossing Status: Indicator Found						
UCIP Comments: Need to contact owner to determine status of crossing. Need date of last inspection and confirmation that crossing is still in operable condition.						
FIELD_STRUCT_DESC: 16-inch steel gas line through levee, 3.0 feet below the crown. Concrete inspection chamber (24x18-inch with 4-inch walls) on the waterward shoulder, covered with dirt. Gas line marker on landward slope. Extends underneath Dry Creek channel, covered with concrete slab approx. 18-inches wide. (Permit No. 789-1939). This entry matches the Drainage or Irrigation Structure referenced in O&M manual (HLM 0.63).						
FS Date: 3/20/2014

Contact information for gas pipeline.

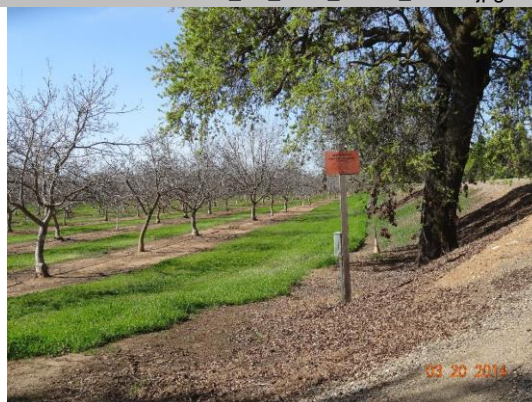
Photo 1 of 2 : UCIP_FA_2016_39988_71890.jpg

LM Start	0.81	Rating **	M	Issue No.	36
LM End	0.81	Issue Type +	En	Location *	LS
Category	Supplemental			GPS Latitude/Longitude	
				Start	End
Item	DWR UCIP Field Study			39.024725 °	39.024725 °
				-121.440978 °	-121.440978 °
DWR ID					
Comment Code					
Inspector Comment					
FS_ID:39988					
DS_ID:24880					
EP_NO: N/A					
Repair Type: Non-Urgent					
Crossing Status: Indicator Found					
UCIP Comments: No marker found on waterward side--need to confirm with owner if crossing goes through levee. If so, need depth of crossing through levee. Also need to obtain permit number used to authorize crossing.					
FIELD_STRUCT_DESC: Conduit line through levee. Marker visible on landward side.					
FS Date: 3/4/2014

Underground cable line marker visible on landward side toe.

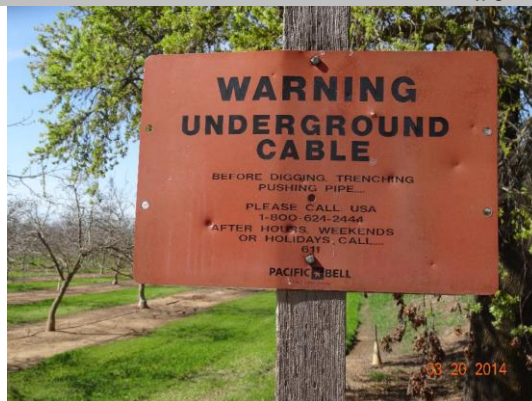
Photo 2 of 2 : UCIP_FA_2016_39988_71889.jpg

LM Start	0.81	Rating **	M	Issue No.	36 (cont)	
LM End	0.81	Issue Type +	En	Location *	LS	
Category	Supplemental			GPS Latitude/Longitude		
				Start	End	
Item	DWR UCIP Field Study			39.024725 °	39.024725 °	
				-121.440978 °	-121.440978 °	
DWR ID						
Comment Code						
Inspector Comment						
FS_ID:39988						
DS_ID:24880						
EP_NO: N/A						
Repair Type: Non-Urgent						
Crossing Status: Indicator Found						
UCIP Comments: No marker found on waterward side--need to confirm with owner if crossing goes through levee. If so, need depth of crossing through levee. Also need to obtain permit number used to authorize crossing.						
FIELD_STRUCT_DESC: Conduit line through levee. Marker visible on landward side.						
FS Date: 3/4/2014

Marker is for underground cable line owned by Pacific Bell.

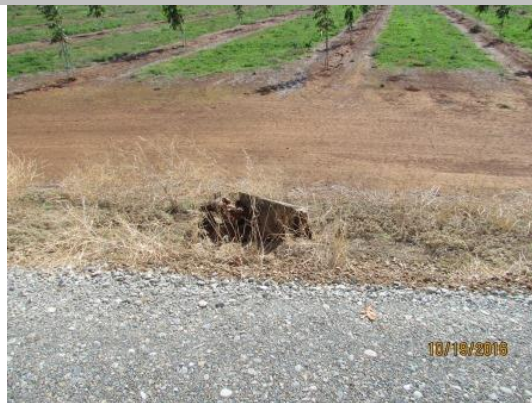
Photo 1 of 1 : FA_2016_RD2103_10_26_20161025_00039.jpg

LM Start	1.27	Rating **	N	Issue No.	26
LM End	1.27	Issue Type +	Ma	Location *	LS
Category	Earthen Levee			GPS Latitude/Longitude	
				Start	End
Item	Trim / Thin Trees			39.027261 °	39.027261 °
				-121.433269 °	-121.433269 °
DWR ID	DWR_RD2103_01_s_2016_26				
Comment Code					
T5 : Tree stumps.					
Inspector Comment					
Stump needs to be removed fom slope. Fall 2016.

View of tree stump on lanside levee slope. Fall 2016.

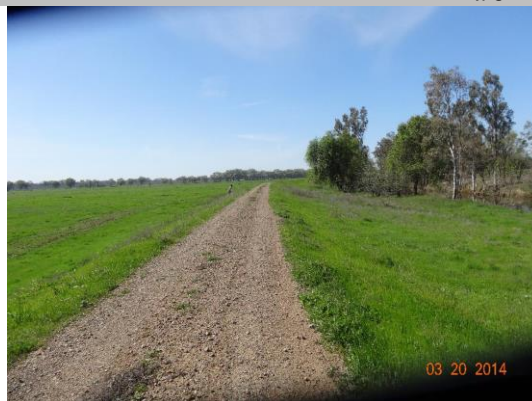
Photo 1 of 2 : UCIP_FA_2016_41183_69917.jpg

FS_ID:41183
DS_ID:19473
EP_NO: 1886
Repair Type: Non-Urgent
Crossing Status: Indicator Found
UCIP Comments: Need to coordinate with owner. Severely corroded section of steel pipe present on waterward side--no other evidence present at this location. Owner will need to coordinate with CVFPB and DWR-Inspector to determine proper action to abandon crossing.
FIELD_STRUCT_DESC: *ABANDONED* 12-inch steel irrigation pipe through the levee, 3.1 feet below the crown. Siphon breaker on the waterward slope. Concrete standpipe at the landward toe. Vertical pump on waterward side. Open on waterward end. Permit includes gravel dam through channel of Dry Creek. (Permit No. 1886-1959). This entry matches the Drainage or Irrigation Structure referenced in O&M manual (HLM 1.86). Crossing is angled 45 degrees.
FS Date: 3/20/2014

Overview of levee crown.

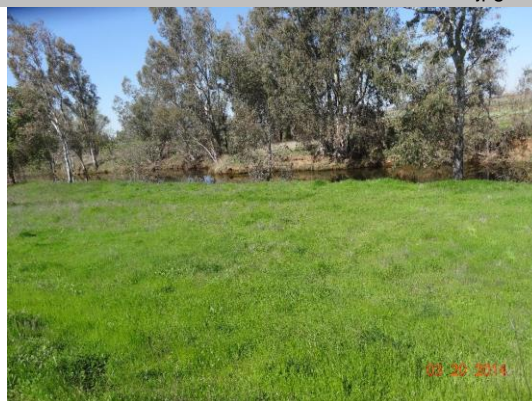
Photo 2 of 2 : UCIP_FA_2016_41183_69916.jpg

View of waterward side.

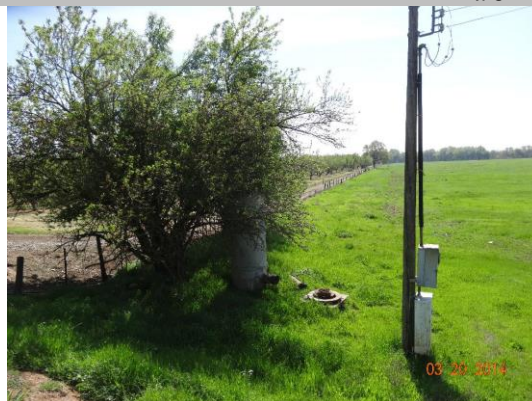
Photo 1 of 2 : UCIP_FA_2016_38327_69881.jpg

LM Start	1.86	Rating **	M	Issue No.	30
LM End	1.86	Issue Type +	En	Location *	LS
Category	Supplemental			GPS Latitude/Longitude	
				Start	End
Item	DWR UCIP Field Study			39.029694 °	39.029694 °
				-121.423946 °	-121.423946 °
DWR ID					
Comment Code					
Inspector Comment					
FS_ID:38327					
DS_ID:19512					
EP_NO: N/A					
Repair Type: Non-Urgent					
Crossing Status: Indicator Found					
UCIP Comments: Unable to determine if there is a crossing through pipe. Will need to coordinate with owner to determine additional information about appurtenances found on landward side.					
FIELD_STRUCT_DESC: Irrigation pump, service pole, and 36-inch concrete standpipe, 5 feet from the landward toe. No pump was found during field visit 3/20/14.					
FS Date: 3/20/2014

View of landward side.

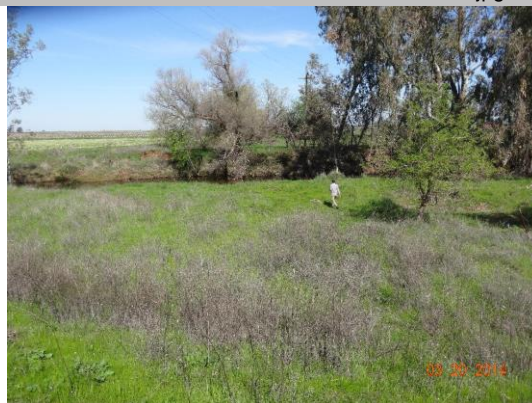
Photo 2 of 2 : UCIP_FA_2016_38327_69880.jpg

View of waterward side.

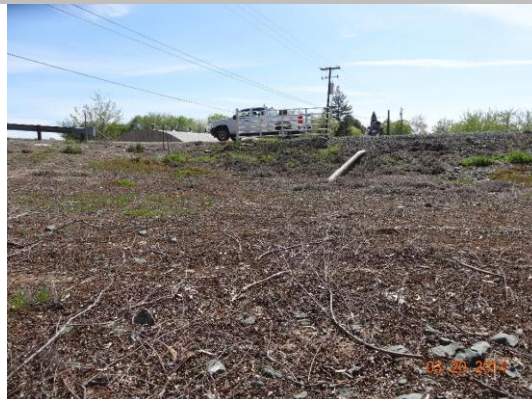
Photo 1 of 2 : UCIP_FA_2016_38331_69894.jpg

LM Start	2.64	Rating **	M	Issue No.	27
LM End	2.64	Issue Type +	En	Location *	LS
Category	Supplemental			GPS Latitude/Longitude	
				Start	End
Item	DWR UCIP Field Study			39.031590 °	39.031590 °
				-121.409870 °	-121.409870 °
DWR ID					
Comment Code					
Inspector Comment					
FS_ID:38331					
DS_ID:19477					
EP_NO: N/A					
Repair Type: Non-Urgent					
Crossing Status: Found					
UCIP Comments: Need to contact owner to determine status.					
FIELD_STRUCT_DESC: 8-inch steel irrigation pipe through the levee, 3.1 feet below the crown. Siphon breaker on the waterward slope. Pump on the landward side. Pipe crosses creek to orchard on north side (Permit No. 1887, 1954. (USACE-1962). This entry matches the Drainage or Irrigation Structure referenced in O&M manual (HLM 2.68). FS Date: 3/20/2014

View of waterward side.

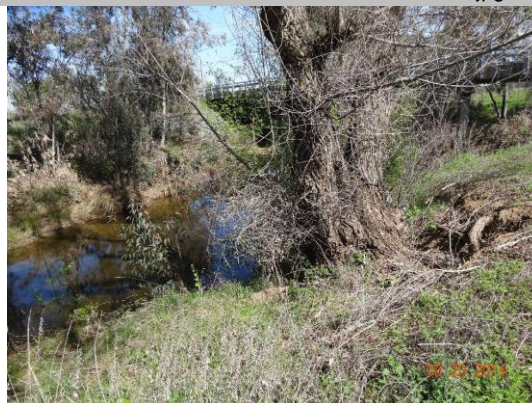
Photo 2 of 2 : UCIP_FA_2016_38331_69893.jpg

Crossing was not visible on waterward side.

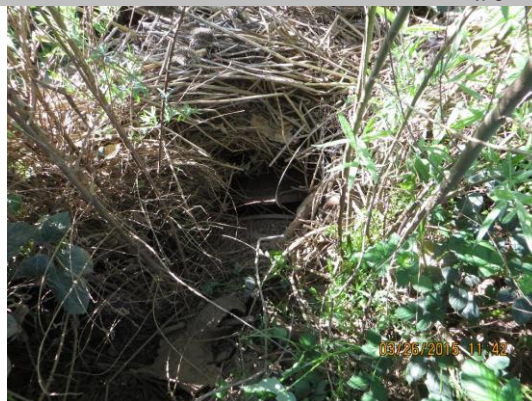
Photo 1 of 2 : UCIP_FA_2016_50033_73429.jpg

Comment Code					
Inspector Comment					
FS_ID:50033 DS_ID:19478 EP_NO: N/A Repair Type: Urgent Crossing Status: Found UCIP Comments: 7/08/2016 Meet with Tom Engler from MBK Engineers, District Engineer, and the District is in the process of trying to deauthorize portion of Unit 1. This section of the levee protects an orchard--levee is approximately 3-4 feet tall. (DWR UCIP - omagana)3/26/2015 Flapgate open and won't close due to vegetation and soil blocking its operation. (DWR UCIP - omagana) FIELD_STRUCT_DESC: 24-inch corrugated metal drainage pipe through the levee, 12 feet below the crown. Flap gate is located on the waterside (WS) end. [Additional Reference(s): DWR Levee Log, 2005]. FS Date: 7/8/2016 11:37:00 AM

Flapgate at WS berm blocked by soil and vegetation bu8ildup.

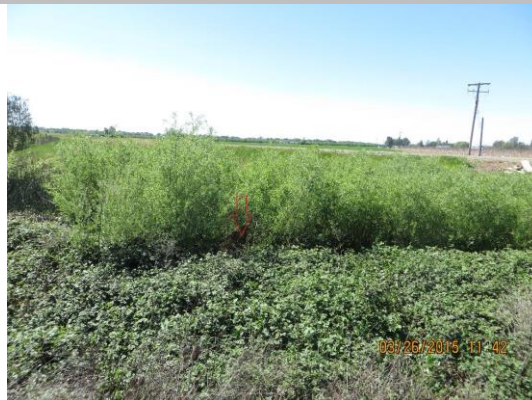
Photo 2 of 2 : UCIP_FA_2016_50033_73428.jpg

Location of pipe and flapgate on WS berm.

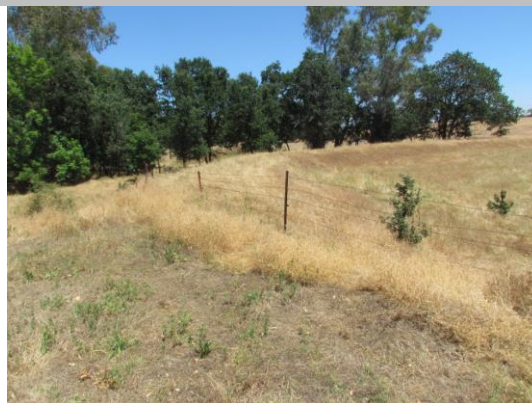
Photo 1 of 1 : FA_2016_RD2103_10_20_20160906_00004.jpg

View of the fence blocking access to the crown of the levee. View is from the crown facing upstream.

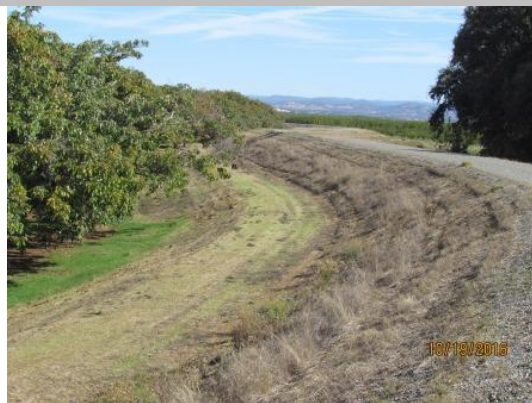
Photo 1 of 1 : FA_2016_RD2103_11_3_20161025_00037.jpg

View of well maintained vegetation on landside looking upstream. Fall 2016.

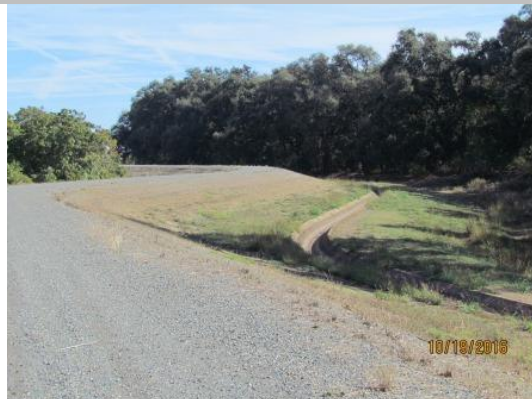
Photo 1 of 1 : FA_2016_RD2103_11_16_20161025_00033.jpg

View of well maintained vegetation on waterside looking upstream. Fall 2016.

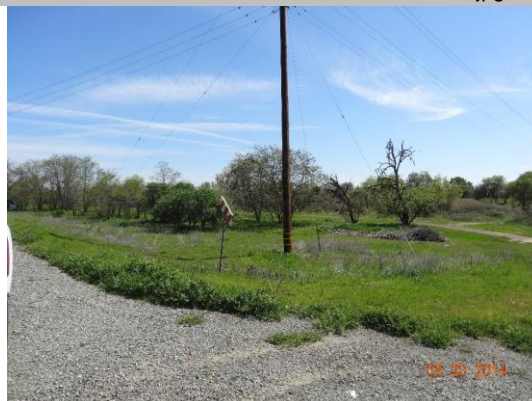
Photo 1 of 2 : UCIP_FA_2016_39992_69914.jpg

LM Start	1.26	Rating **	M	Issue No.	29
LM End	1.26	Issue Type +	En	Location *	WS
Category	Supplemental			GPS Latitude/Longitude	
				Start	End
Item	DWR UCIP Field Study			38.998301 °	38.998301 °
				-121.415296 °	-121.415296 °
DWR ID					
Comment Code					
Inspector Comment					
FS_ID:39992					
DS_ID:19484					
EP_NO: 1613					
Repair Type: Non-Urgent					
Crossing Status: Indicator Found					
UCIP Comments: Need to contact owner to determine status of crossing. Need date of last inspection and confirmation that crossing is still in operable condition.					
FIELD_STRUCT_DESC: 16-inch steel gas line through the levee, 3.0 feet below the crown. (Permit No. 1613-1951). This entry matches the Drainage or Irrigation Structure referenced in O&M manual (HLM 1.30).					
FS Date: 3/20/2014

Marker visible on waterward side.

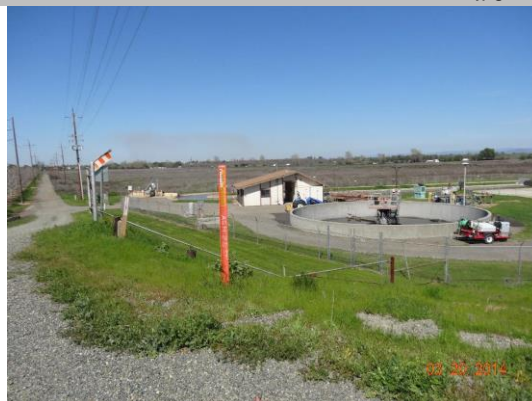
Photo 2 of 2 : UCIP_FA_2016_39992_69913.jpg

LM Start	1.26	Rating **	M	Issue No.	29 (cont)	
LM End	1.26	Issue Type +	En	Location *	WS	
Category	Supplemental			GPS Latitude/Longitude		
				Start	End	
Item	DWR UCIP Field Study			38.998301 °	38.998301 °	
				-121.415296 °	-121.415296 °	
DWR ID						
Comment Code						
Inspector Comment						
FS_ID:39992						
DS_ID:19484						
EP_NO: 1613						
Repair Type: Non-Urgent						
Crossing Status: Indicator Found						
UCIP Comments: Need to contact owner to determine status of crossing. Need date of last inspection and confirmation that crossing is still in operable condition.						
FIELD_STRUCT_DESC: 16-inch steel gas line through the levee, 3.0 feet below the crown. (Permit No. 1613-1951). This entry matches the Drainage or Irrigation Structure referenced in O&M manual (HLM 1.30).						
FS Date: 3/20/2014

Marker visible on landward side.

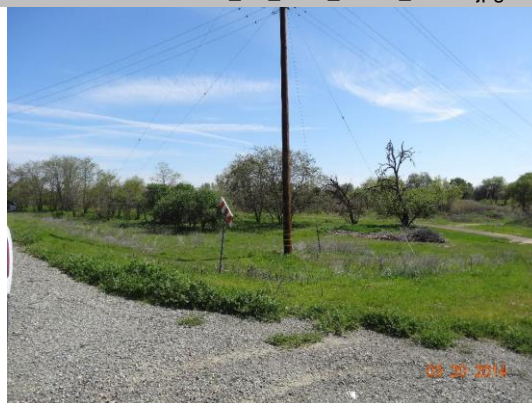
Photo 1 of 2 : UCIP_FA_2016_39993_69912.jpg

Comment Code					
Inspector Comment					
FS_ID:39993					
DS_ID:19486					
EP_NO: 5714					
Repair Type: Non-Urgent					
Crossing Status: Indicator Found					
UCIP Comments: Need to contact owner to confirm crossing and determine status.					
FIELD_STRUCT_DESC: 12-inch steel sewer pipes through the levee, 3.1 feet below the crown. Siphon breaker in 24-inch CM pipe riser on the landward shoulder. Standard CM cutoff wall around pipe at centerline of levee. Extends from wastewater treatment plant on landward side to waste water lagoon on waterward side. Permit includes construction of lagoon with surrounding short levee, extending from/to project levee. (Permit No. 5714-1968).					
FS Date: 3/20/2014

View of waterward side.

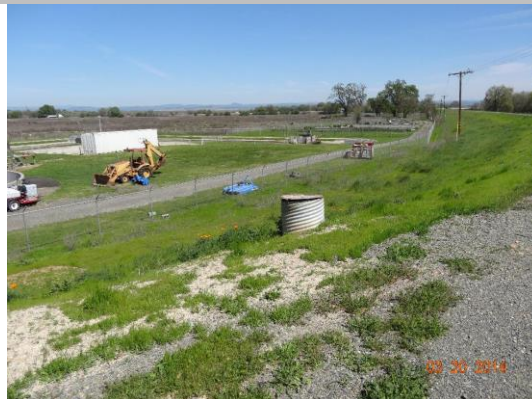
Photo 2 of 2 : UCIP_FA_2016_39993_69911.jpg

Comment Code						
Inspector Comment						
FS_ID:39993						
DS_ID:19486						
EP_NO: 5714						
Repair Type: Non-Urgent						
Crossing Status: Indicator Found						
UCIP Comments: Need to contact owner to confirm crossing and determine status.						
FIELD_STRUCT_DESC: 12-inch steel sewer pipes through the levee, 3.1 feet below the crown. Siphon breaker in 24-inch CM pipe riser on the landward shoulder. Standard CM cutoff wall around pipe at centerline of levee. Extends from wastewater treatment plant on landward side to waste water lagoon on waterward side. Permit includes construction of lagoon with surrounding short levee, extending from/to project levee. (Permit No. 5714-1968).						
FS Date: 3/20/2014

CMP riser located on landward side.

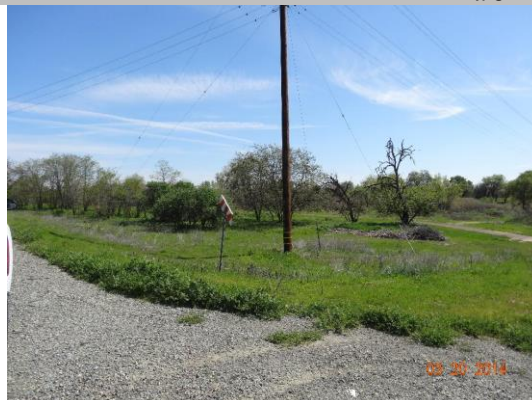
Photo 1 of 2 : UCIP_FA_2016_39994_69905.jpg

LM Start	1.29	Rating **	M	Issue No.	31
LM End	1.29	Issue Type +	En	Location *	WS
Category	Supplemental			GPS Latitude/Longitude	
				Start	End
Item	DWR UCIP Field Study			38.998322 °	38.998322 °
				-121.414688 °	-121.414688 °
DWR ID					
Comment Code					
Inspector Comment					
FS_ID:39994					
DS_ID:19509					
EP_NO: N/A					
Repair Type: Non-Urgent					
Crossing Status: Indicator Found					
UCIP Comments: Need to contact owner to determine details of the crossing through levee.					
FIELD_STRUCT_DESC: Wheatland Sewage Disposal Plant on waterward side, treatment plant on landward side. Service pole on waterward slope.					
FS Date: 3/20/2014

View of waterward side.

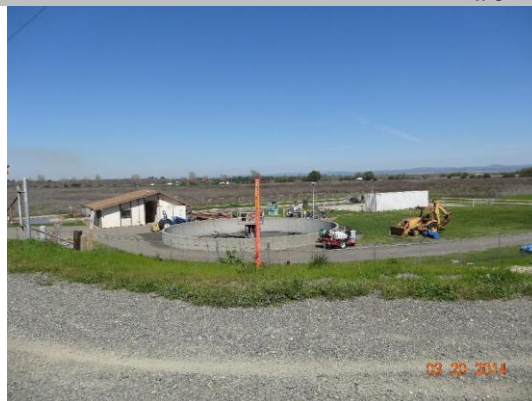
Photo 2 of 2 : UCIP_FA_2016_39994_69904.jpg

LM Start	1.29	Rating **	M	Issue No.	31 (cont)
LM End	1.29	Issue Type +	En	Location *	WS
Category	Supplemental			GPS Latitude/Longitude	
				Start	End
Item	DWR UCIP Field Study			38.998322 °	38.998322 °
				-121.414688 °	-121.414688 °
DWR ID					
Comment Code					
Inspector Comment					
FS_ID:39994					
DS_ID:19509					
EP_NO: N/A					
Repair Type: Non-Urgent					
Crossing Status: Indicator Found					
UCIP Comments: Need to contact owner to determine details of the crossing through levee.					
FIELD_STRUCT_DESC: Wheatland Sewage Disposal Plant on waterward side, treatment plant on landward side. Service pole on waterward slope.					
FS Date: 3/20/2014

View of water treatment located on landward side, photo 1 of 3.

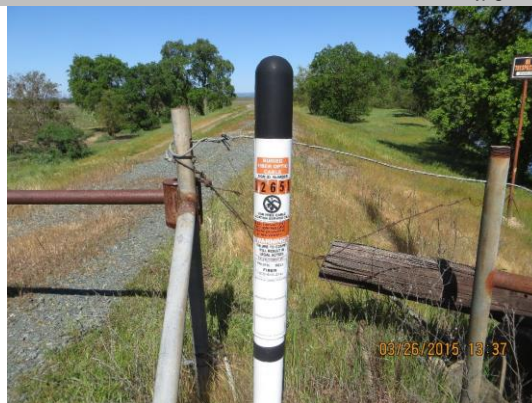
Photo 1 of 2 : UCIP_FA_2016_44089_73568.jpg

LM Start	1.76	Rating **	M	Issue No.	32
LM End	1.76	Issue Type +	En	Location *	WS
Category	Supplemental			GPS Latitude/Longitude	
				Start	End
Item	DWR UCIP Field Study			39.000557 °	39.000557 °
				-121.406581 °	-121.406581 °
DWR ID					
Comment Code					
Inspector Comment					
FS_ID:44089 DS_ID:25090 EP_NO: N/A Repair Type: Non-Urgent Crossing Status: Found UCIP Comments: No permit identified for this crossing. FIELD_STRUCT_DESC: Fiberoptic line through the levee at unknown depth. Marker visible on WS shoulder. 6-inch steel pipe visible on upstream side of railroad trestle. FS Date: 3/26/2015

Fiberoptic line marker on crown of levee

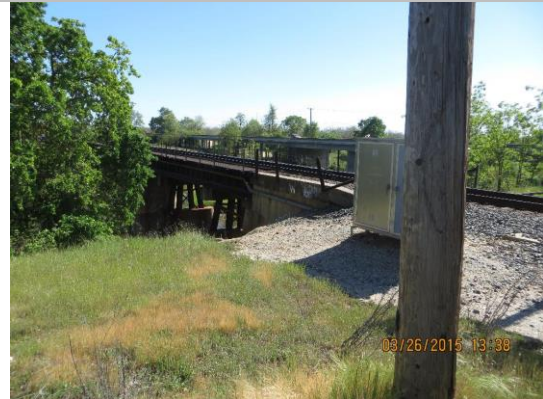
Photo 2 of 2 : UCIP_FA_2016_44089_73567.jpg

LM Start	1.76	Rating **	M	Issue No.	32 (cont)
LM End	1.76	Issue Type +	En	Location *	WS
Category	Supplemental			GPS Latitude/Longitude	
				Start	End
Item	DWR UCIP Field Study			39.000557 °	39.000557 °
				-121.406581 °	-121.406581 °
DWR ID					
Comment Code					
Inspector Comment					
FS_ID:44089 DS_ID:25090 EP_NO: N/A Repair Type: Non-Urgent Crossing Status: Found UCIP Comments: No permit identified for this crossing. FIELD_STRUCT_DESC: Fiberoptic line through the levee at unknown depth. Marker visible on WS shoulder. 6-inch steel pipe visible on upstream side of railroad trestle. FS Date: 3/26/2015

6-inch steel conduit visible on upstream side of railroad bridge.

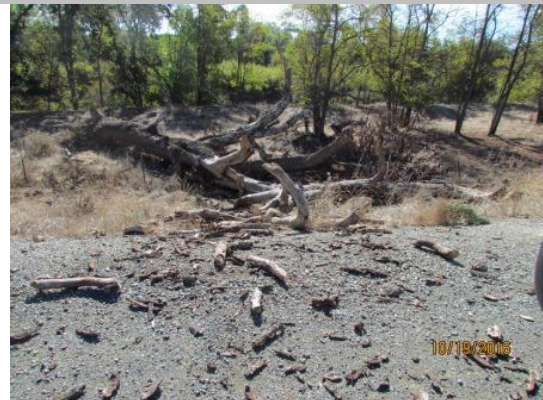
Photo 1 of 1 : FA_2016_RD2103_11_17_20161025_00036.jpg

View of tree that fell on the waterside levee slope. Fall 2016.

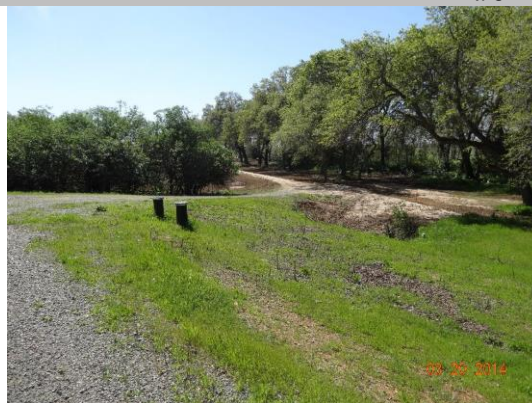
Photo 1 of 2 : UCIP_FA_2016_40045_71908.jpg

LM Start	2.60	Rating **	M	Issue No.	25
LM End	2.60	Issue Type +	En	Location *	LS
Category	Supplemental			GPS Latitude/Longitude	
				Start	End
Item	DWR UCIP Field Study			39.009394 °	39.009394 °
				-121.397300 °	-121.397300 °
DWR ID					
Comment Code					
Inspector Comment					
FS_ID:40045 DS_ID:19488 EP_NO: N/A Repair Type: Non-Urgent Crossing Status: Found UCIP Comments: Pipe has been plugged--visible on landward side. Need to contact owner to obtain additional information about abandoned crossing. FIELD_STRUCT_DESC: 1 of 2: 30-inch diameter CM irrigation pipe through levee, 13.8 feet below crown. Slide gates in 42-diameter riser on waterward slope. Concrete "U" headwall at both levee toes. Grouted spillway on landward side. (USACE-1962). This entry matches the Drainage or Irrigation Structure referenced in O&M manual (HLM 2.67). FS Date: 3/20/2014

View of waterward shoulder.

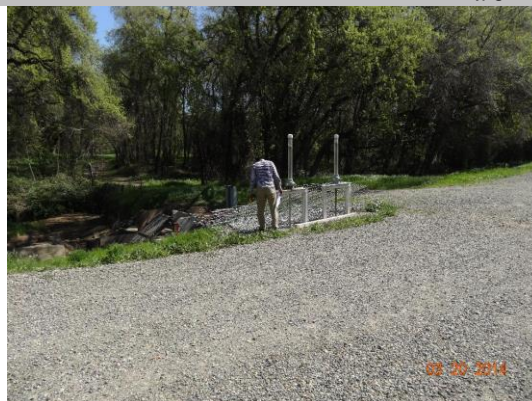
Photo 2 of 2 : UCIP_FA_2016_40045_71907.jpg

Slide gates visible located on landward side.

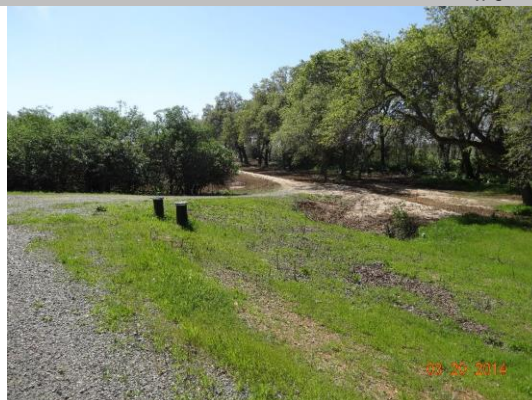
Photo 1 of 2 : UCIP_FA_2016_40046_71915.jpg

View of waterward side.

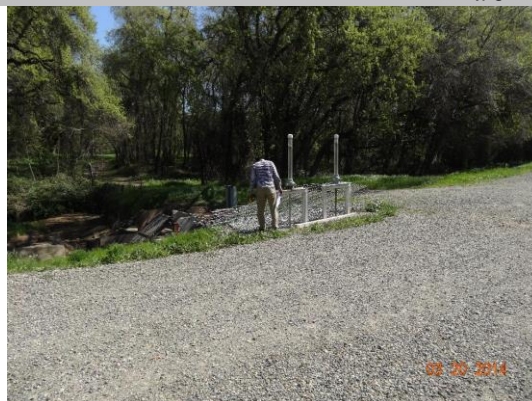
Photo 2 of 2 : UCIP_FA_2016_40046_71914.jpg

View of landward side.

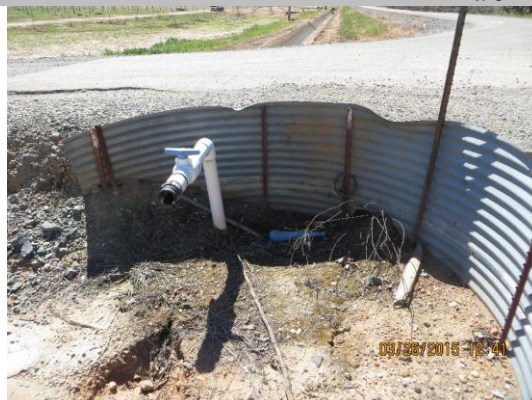
Photo 1 of 2 : UCIP_FA_2016_43957_73435.jpg

Service connection and ball valve visible on LS shoulder.

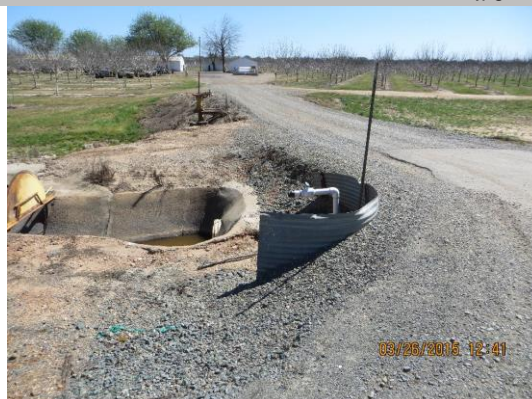
Photo 2 of 2 : UCIP_FA_2016_43957_73434.jpg

Service connection and ball valve visible on LS shoulder.

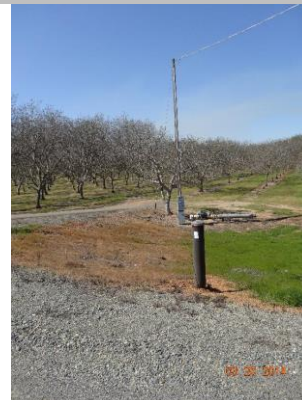
Photo 1 of 2 : UCIP_FA_2016_40048_71922.jpg

View of waterward side.

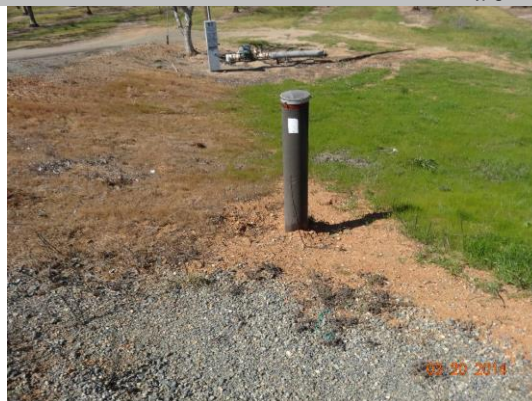
Photo 2 of 2 : UCIP_FA_2016_40048_71921.jpg

Riser located on landward slope.

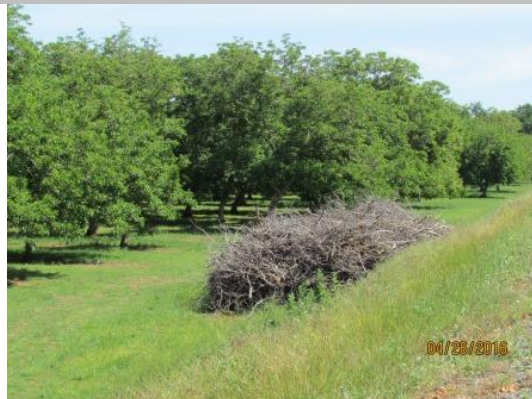
Photo 1 of 2 : FA_2016_RD2103_11_18_20160906_00004.jpg

View of pruning's at landside toe looking upstream. Spring 2016.

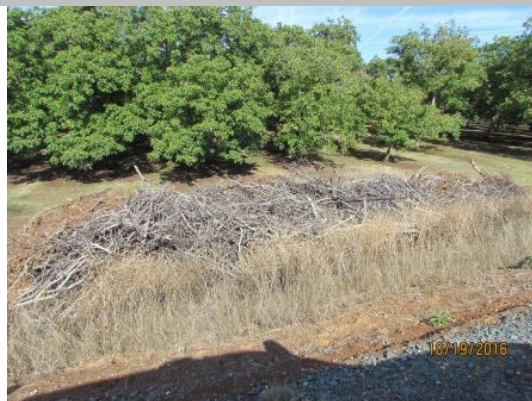
Photo 2 of 2 : FA_2016_RD2103_11_18_20161025_00035.jpg

View of pruning's on landside levee toe that still need to be removed.
Fall 2016.

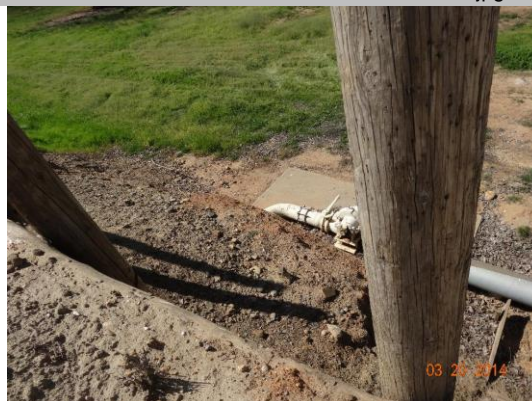
Photo 1 of 2 : UCIP_FA_2016_40049_71928.jpg

Pipe visible on waterward side.

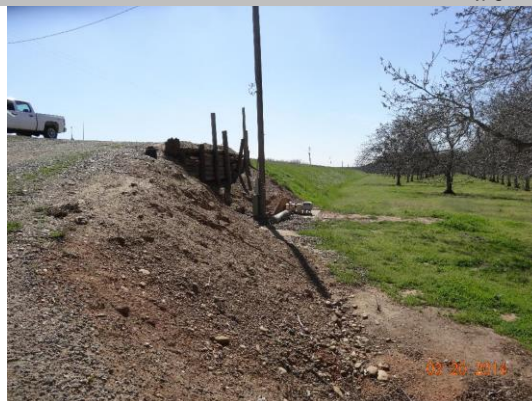
Photo 2 of 2 : UCIP_FA_2016_40049_71926.jpg

Overview of waterward side.
